<25 Problems solved

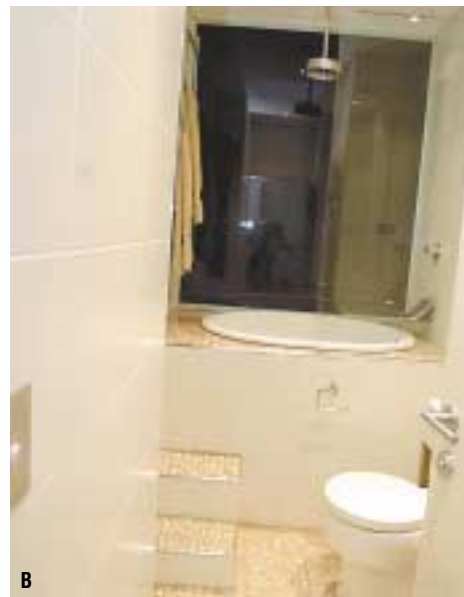
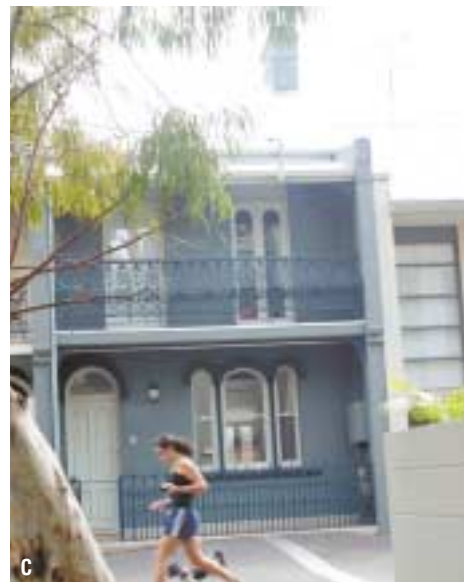
A The front room was opened up and the staircase modernised
B The architects slotted in a bathroom upstairs with a Japanese tub
C The distinctive balustrade had to be kept in character for heritage purposes

A Japanese bath topped by an oversized shower head solved the second problem – it’s deep rather than long and is designed for sitting and soaking instead of lying and wallowing.
